NATIONAL TRANSPORTATION SAFETY BOARD

MATERIALS LABORATORY FACTUAL REPORT

Report No. 18-041

Place : Peach Springs, Arizona
Date : February 10, 2018
Vehicle : Airbus Helicopter (Eurocopter) EC-130 B4, N155GC
NTSB No. : WPR18MA087
Investigator : Chihoon Shin (AS-40)

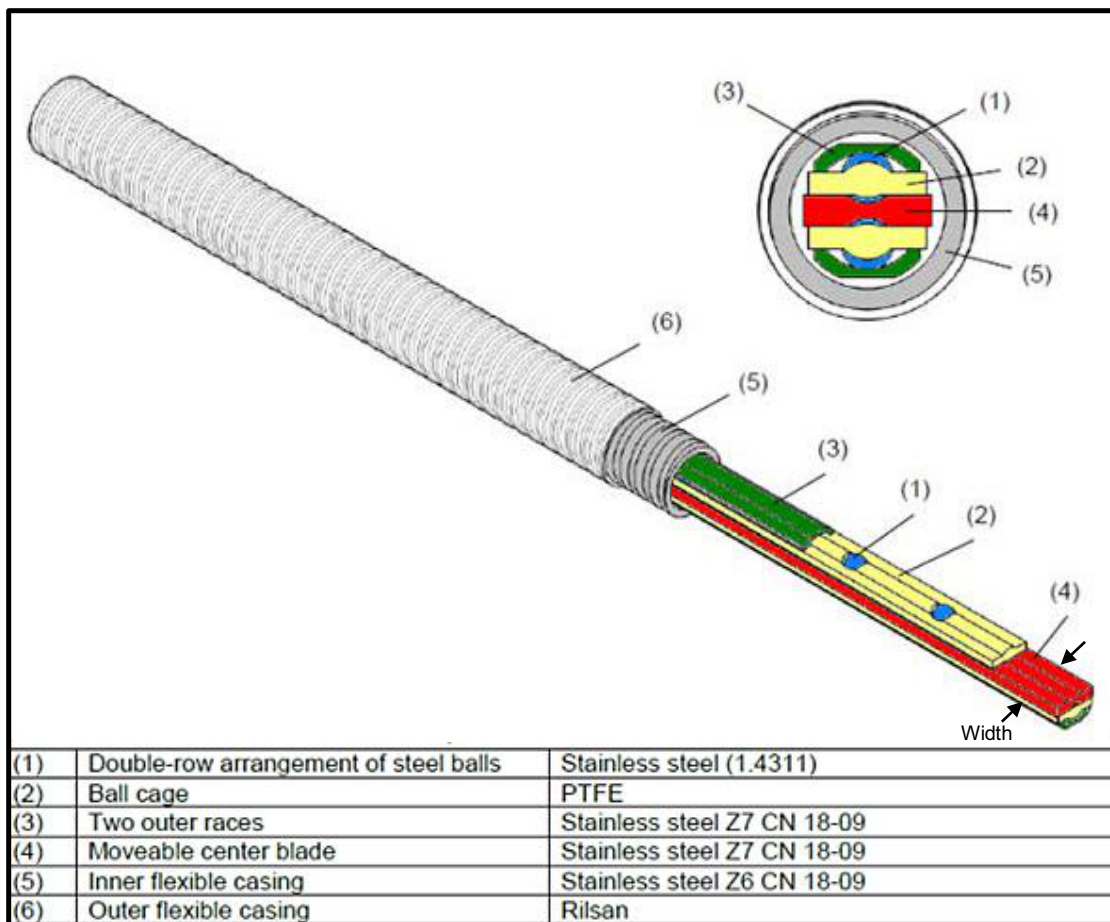
Figure 1 shows a photograph of the as-received Fenestron control cable. Figure 2 shows the cross section of the control cable. Figure 3 show close-up photographs of the fractured ends of the moveable center blade, ball cages, and outer races. Connection between the mobile end rod and the center blade is accomplished by means of a crimping process. The end of the center blade was manufactured with a reduced width portion. The reduced width portion of the center blade is to be inserted into the open end of the mobile end rod and, in turn, the outer surface of the rod end is to be crimped so that the reduced width portion of the center blade is retained inside of the mobile end rod.

Figure 2. Diagram of the Fenestron control cable showing a cross section and description of the internal cable parts. Source: Airbus
